NOTTAWASAGA VALLEY CONSERVATION REPORT

WATER

MINISTRY OF NATURAL RESOURCES

CONSERVATION AUTHORITIES BRANCH

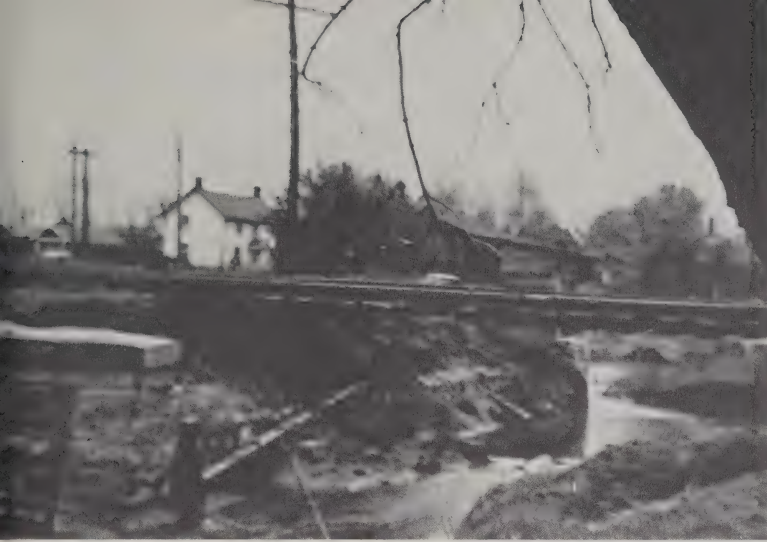
C.N.R. Culvert and railway embankment in Angus were washed out by "Hurricane Hazel" in 1954.

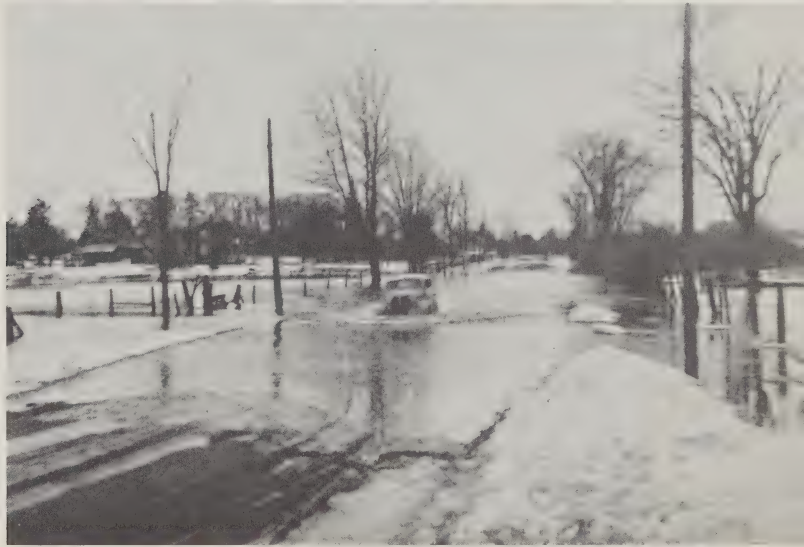
Section of County Road 13, west of Lisle. Replacement of culverts combined with channel improvements would lessen the flood hazard.

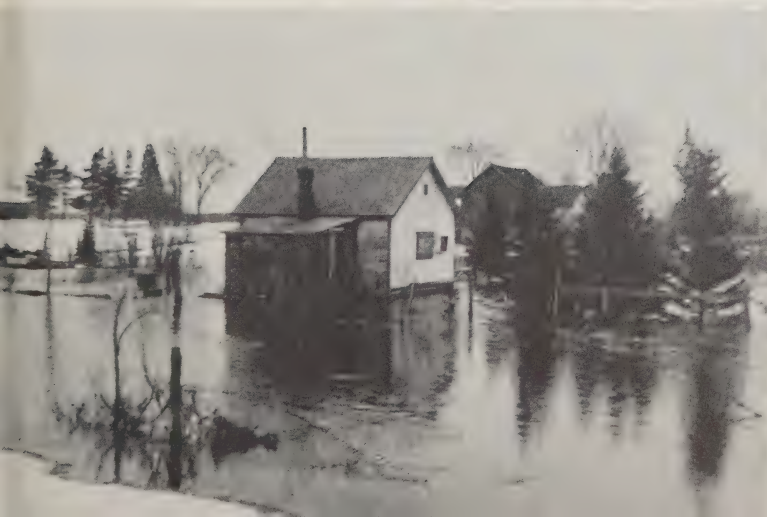
House built in flood plain land at Lisle. Appropriate zoning regulations can prevent situations like this in the future.

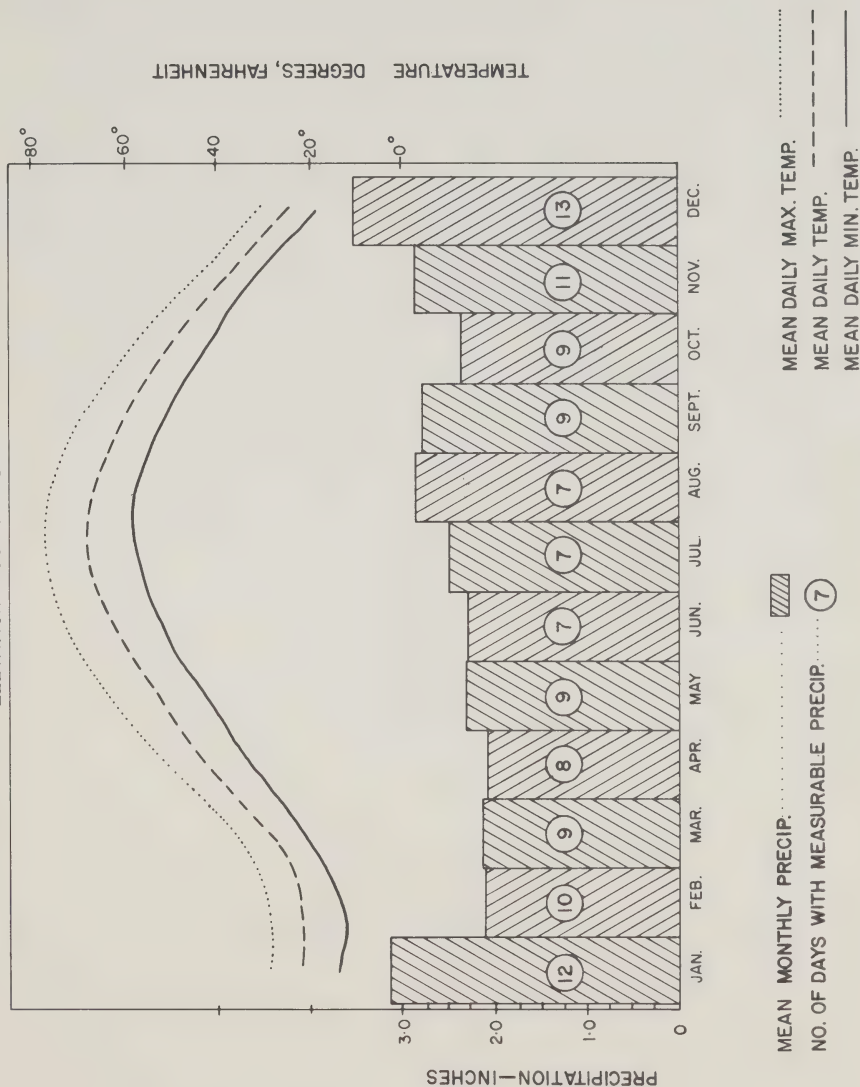
FIG. 1-2

TEMPERATURE AND PRECIPITATION AT THE COLLINGWOOD WEATHER STATION; 30 YEAR NORMALS 1941-1970 .
 LATITUDE 44° 29' N. LONGITUDE 80° 13' W.
 ELEVATION 600 FT. A.S.L.

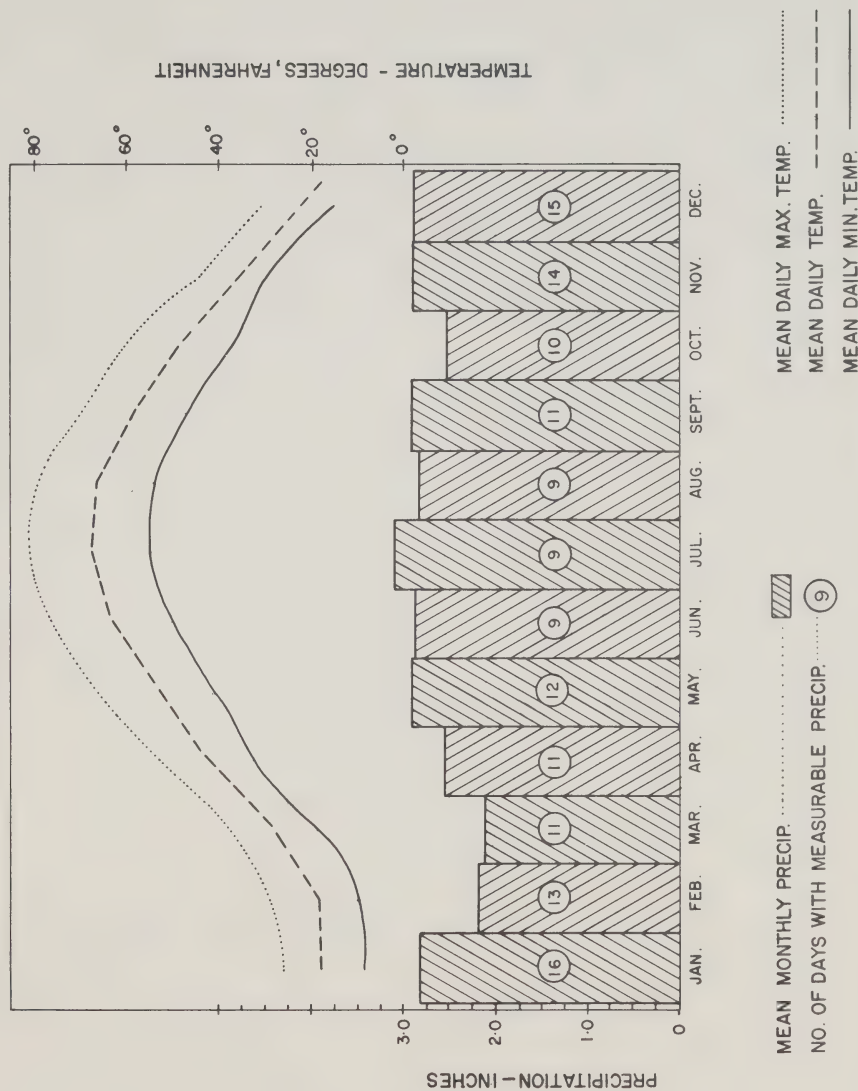
FIG. 1-3

TEMPERATURE AND PRECIPITATION AT THE ANGUS WEATHER STATION; 30 YEAR NORMALS 1941-1970.
 LATITUDE 44° 19' N. LONGITUDE 79° 52' W.

ELEVATION 627 FT A.S.L.

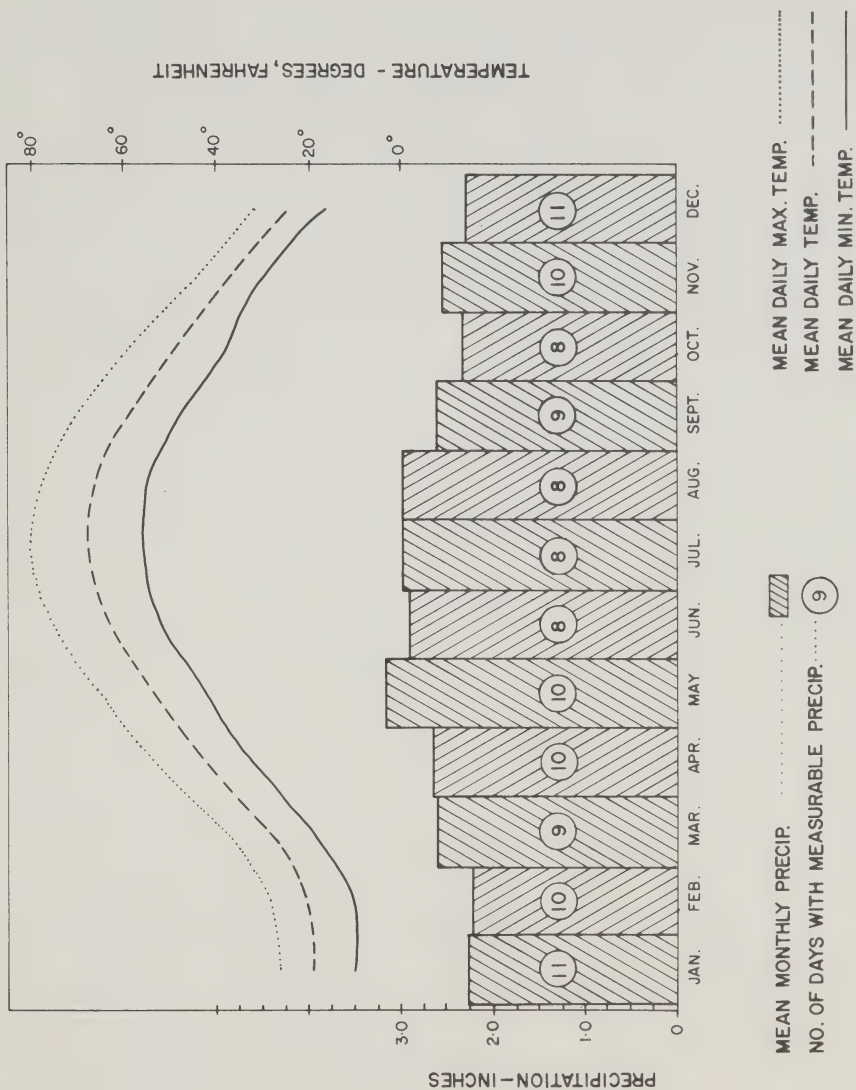
FIG. 1-4

TEMPERATURE AND PRECIPITATION AT THE BEETON WEATHER STATION; 30 YEAR NORMALS 1941-1970
 LATITUDE 44°06'N. LONGITUDE 79°47'W.
 ELEVATION 764 FT. A.S.L.

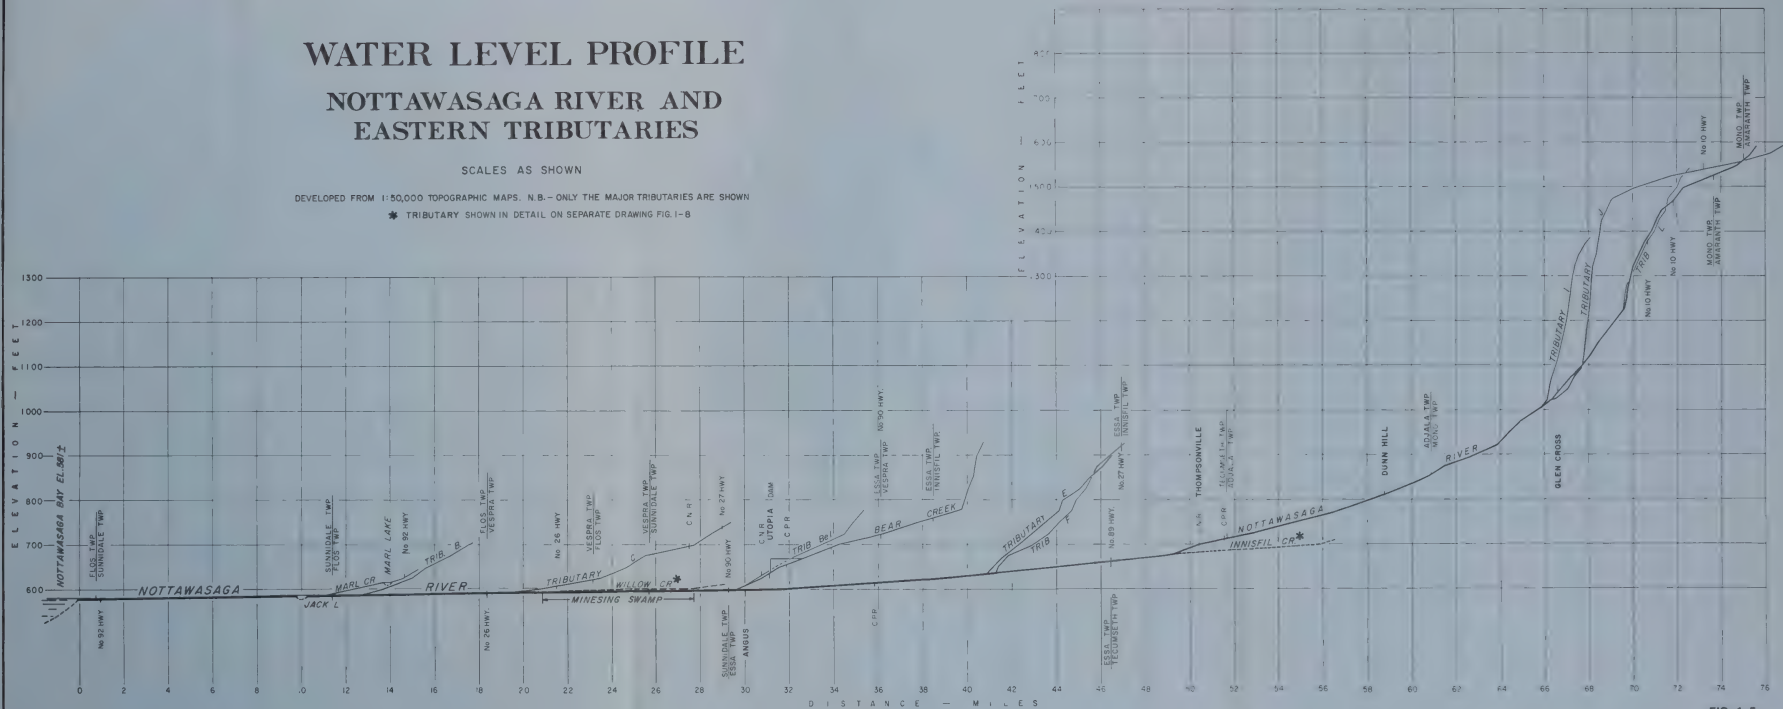
FIG. 1-5

WATER LEVEL PROFILE

DEVELOPED FROM 1:50,000 TOPOGRAPHIC MAPS. N.B. - ONLY THE MAJOR TRIBUTARIES ARE SHOWN

* TRIBUTARY SHOWN IN DETAIL ON SEPARATE DRAWING FIG. 1-8

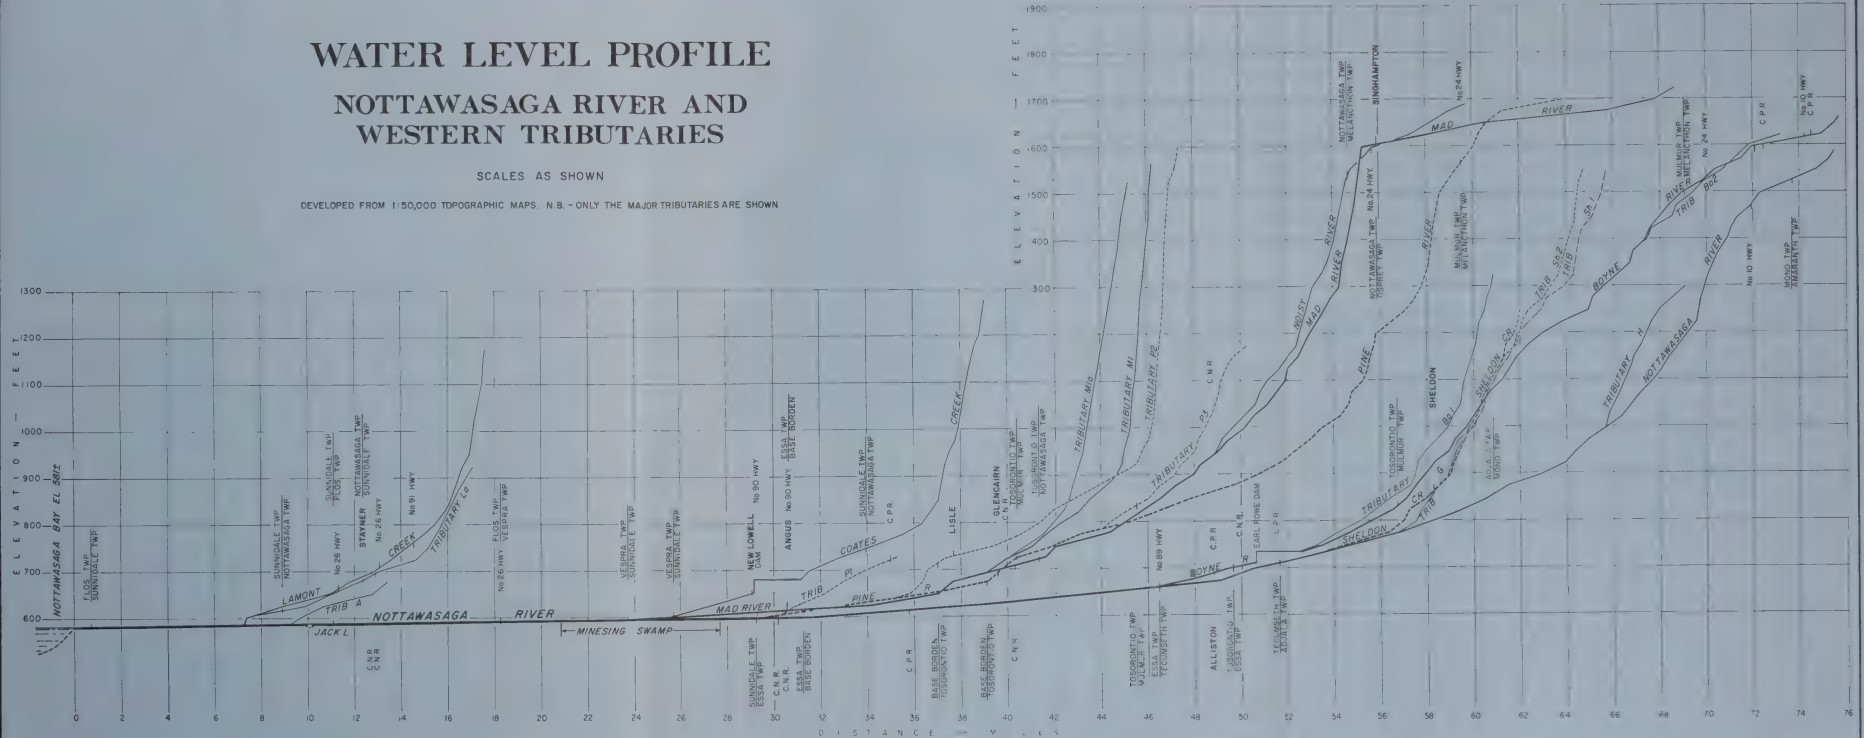
FIG. 1-6

WATER LEVEL PROFILE

DEVELOPED FROM 1:50,000 TOPOGRAPHIC MAPS. N.B. - ONLY THE MAJOR TRIBUTARIES ARE SHOWN

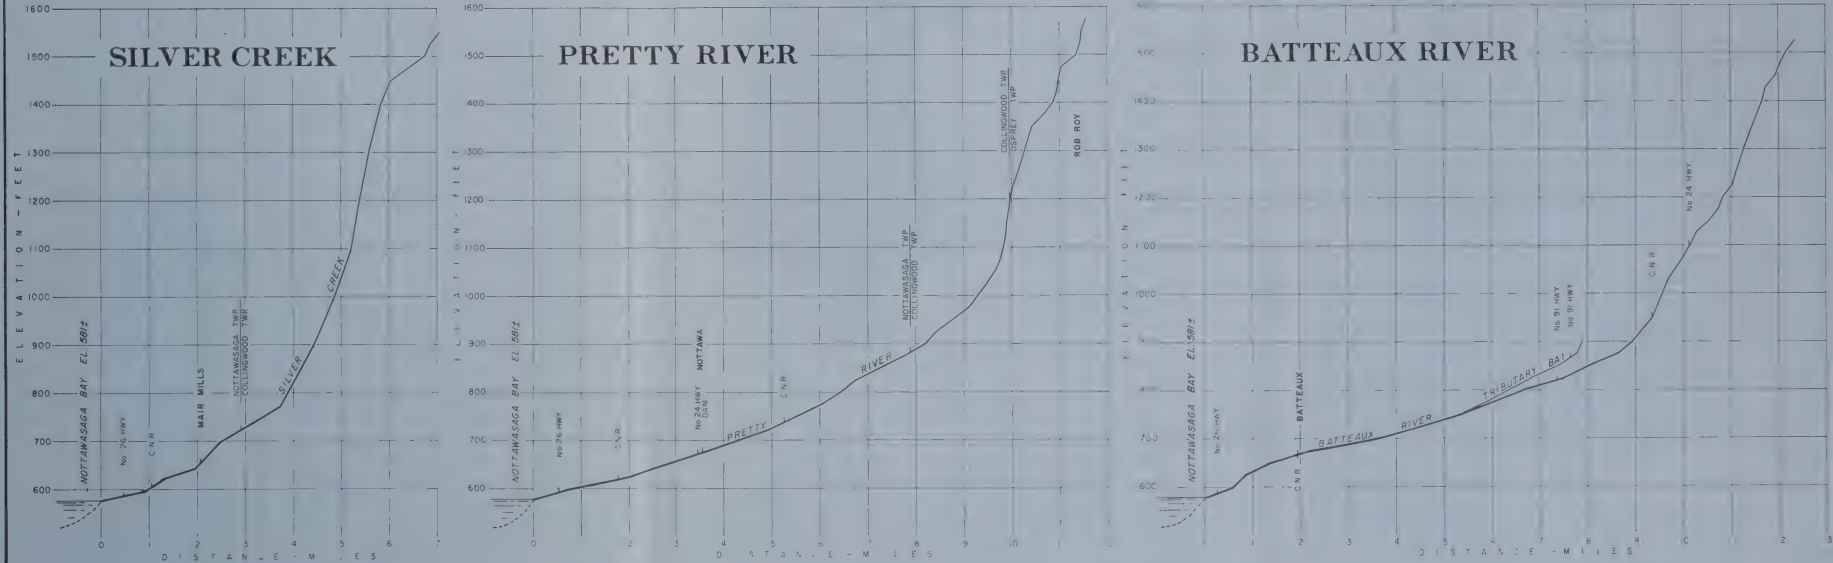
FIG. 1-7

WATER LEVEL PROFILES

DEVELOPED FROM 1:50,000 TOPOGRAPHIC MAPS. N.B. - ONLY THE MAJOR TRIBUTARIES ARE SHOWN

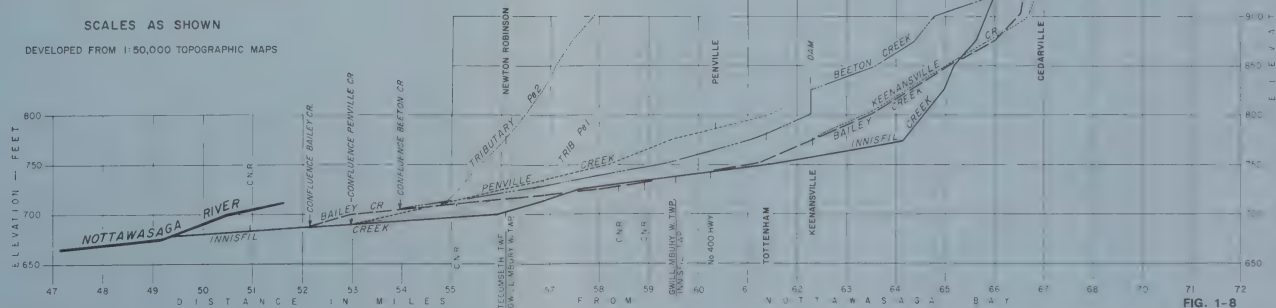
FIG. 1-8

WATER LEVEL PROFILE

DEVELOPED FROM 1:50,000 TOPOGRAPHIC MAPS

INNISFIL CREEK

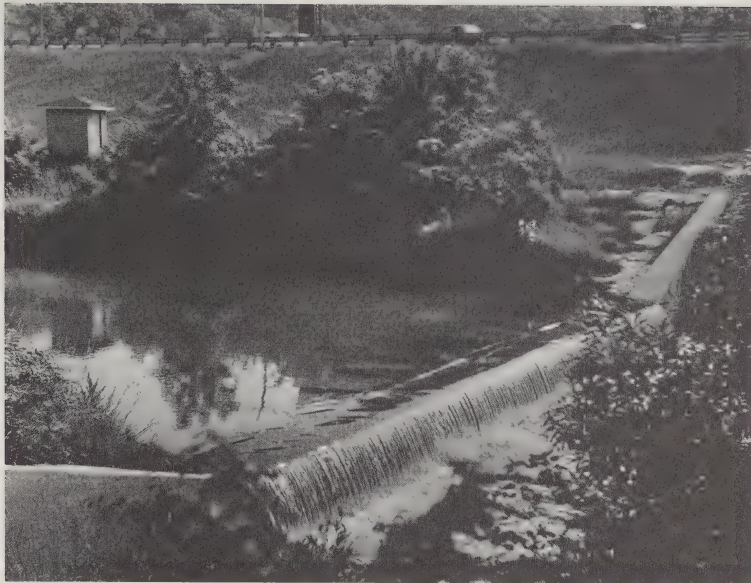
TYPICAL STREAM GAUGE STATION

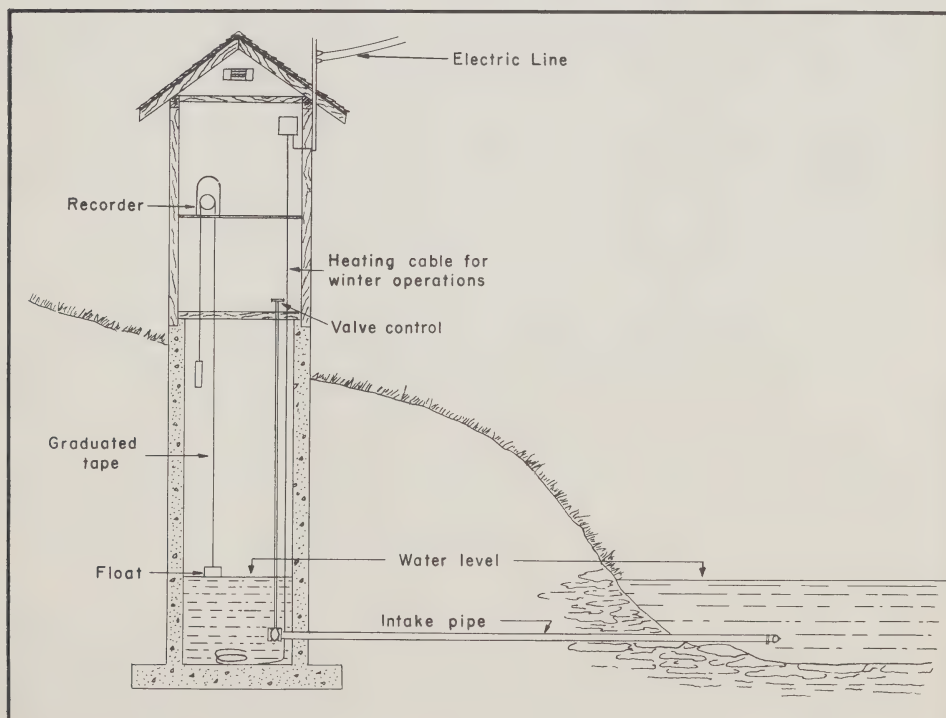
TYPICAL STREAM GAUGE INSTALLATION

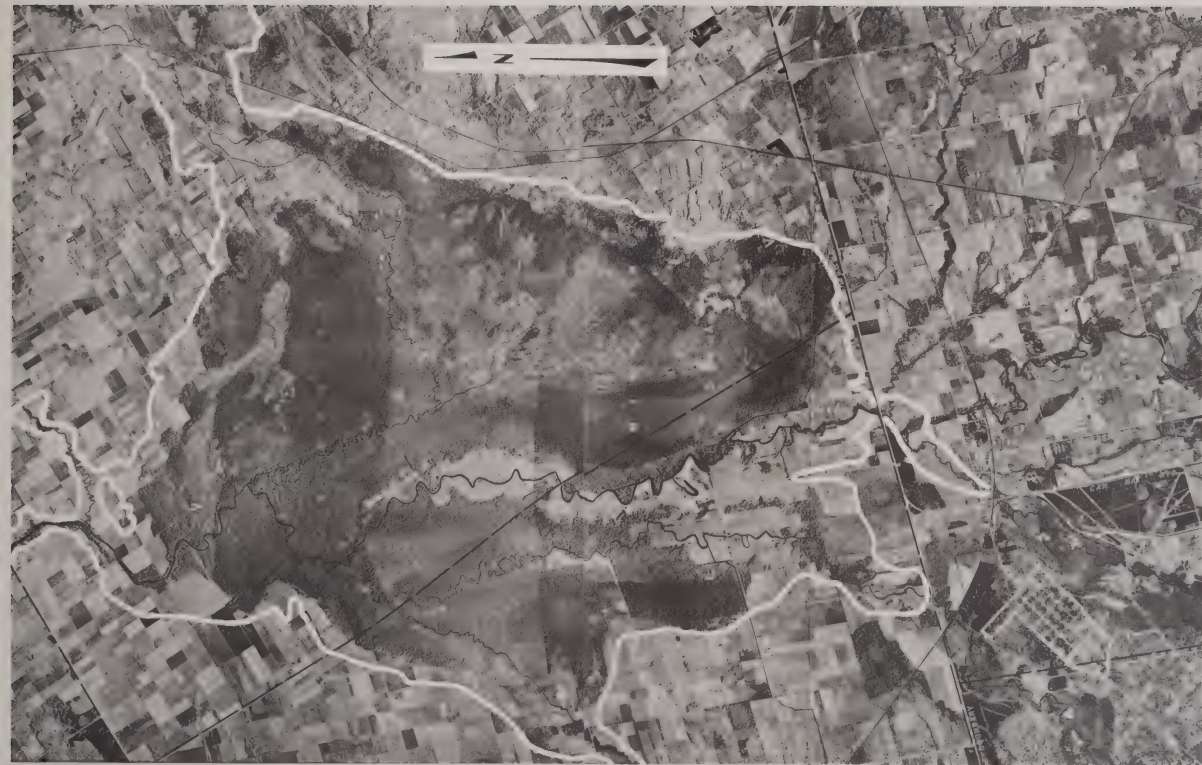
FLOOD PLAIN
OF THE
NOTTAWASAGA RIVER SYSTEM
IN THE
MINESING FLATS
SHOWING THE EXTENT OF THE 1972 SPRING FLOOD

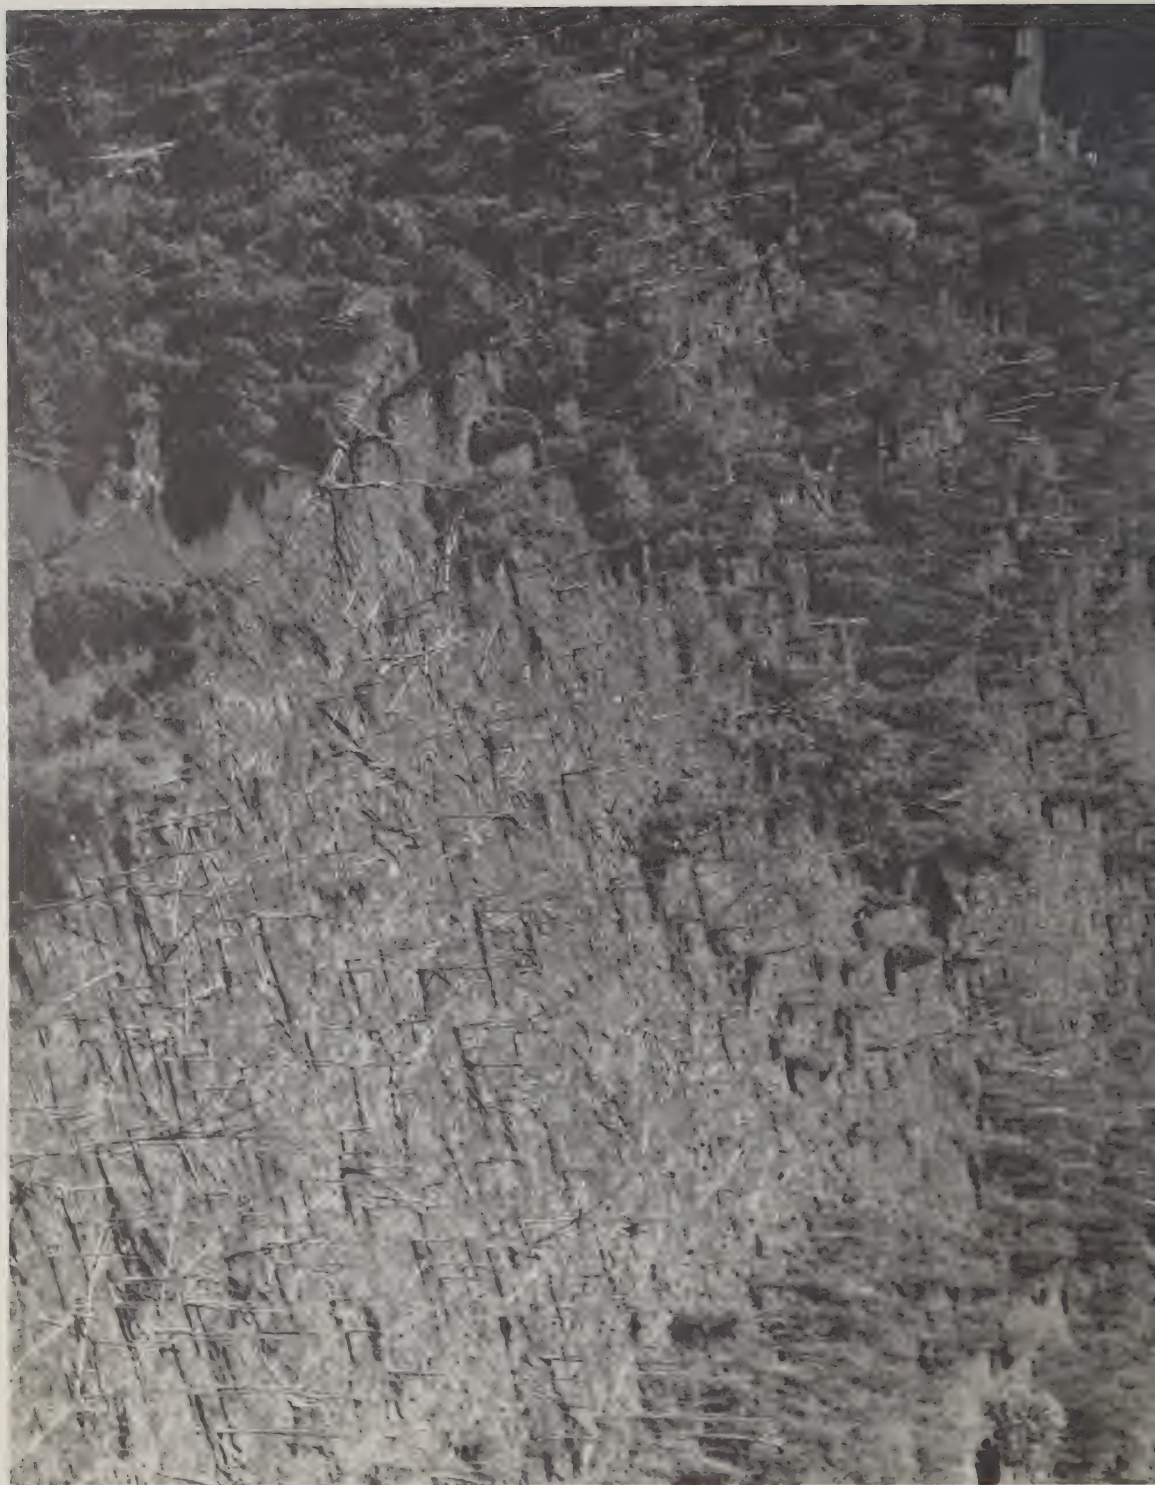
Failure to remove cut trees such as these elms from the flood plain will produce problems such as...

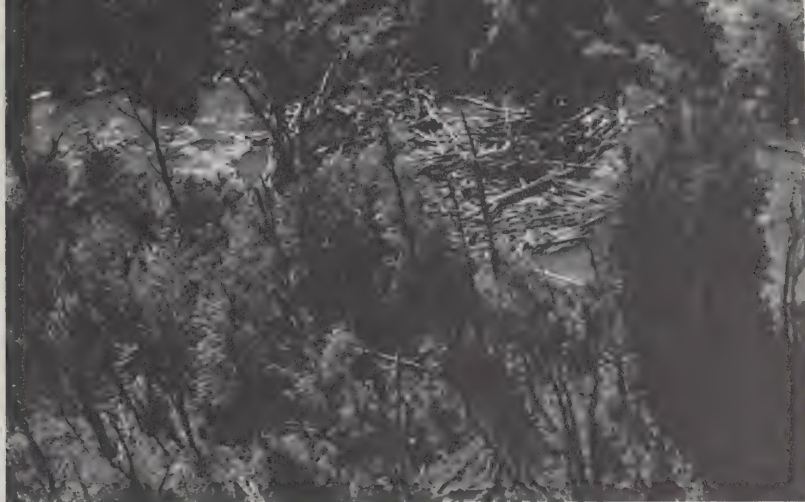
this large log jam on the Mad River. . . .

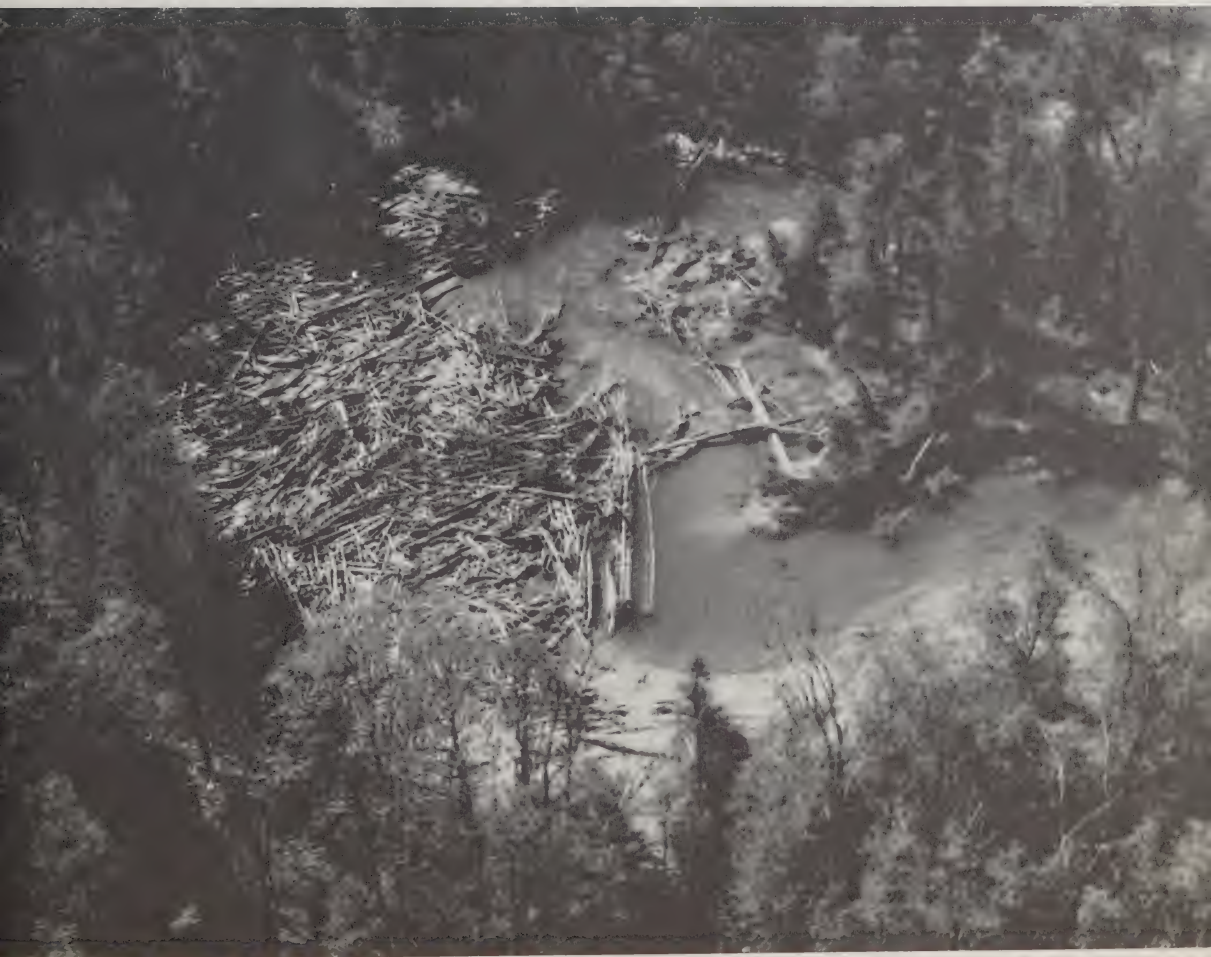
or this log jam on the Pine River near Base Borden.

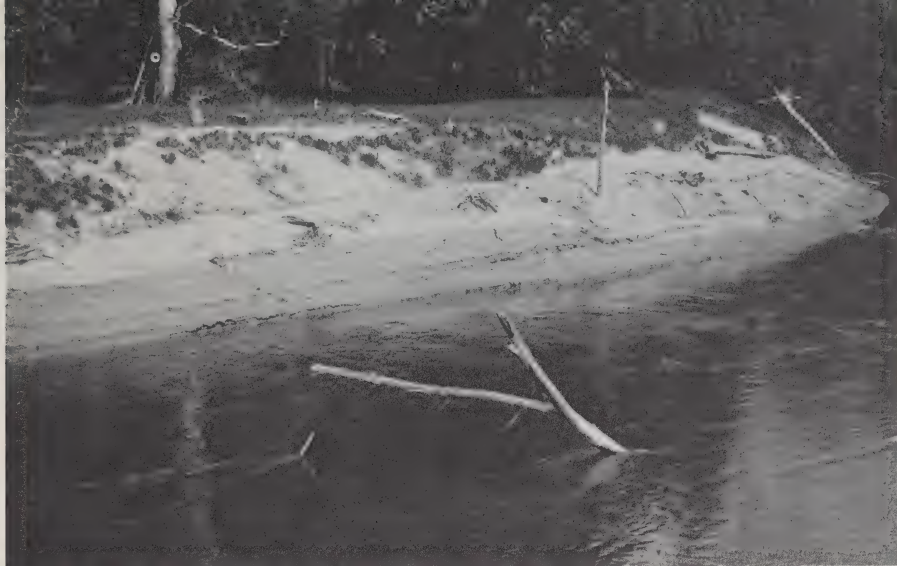
Sediment deposit along the south bank of the Boyne River downstream of a log jam. In this section the River carries a heavy load of sediment.

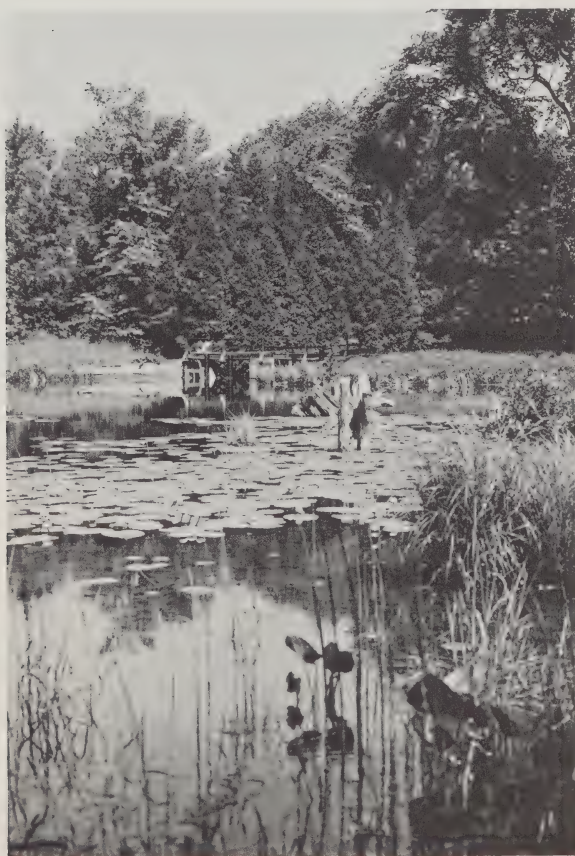
Reservoir on the Noisy River at Maple Valley. Vegetative growth in pond area indicates heavy silt accumulation.

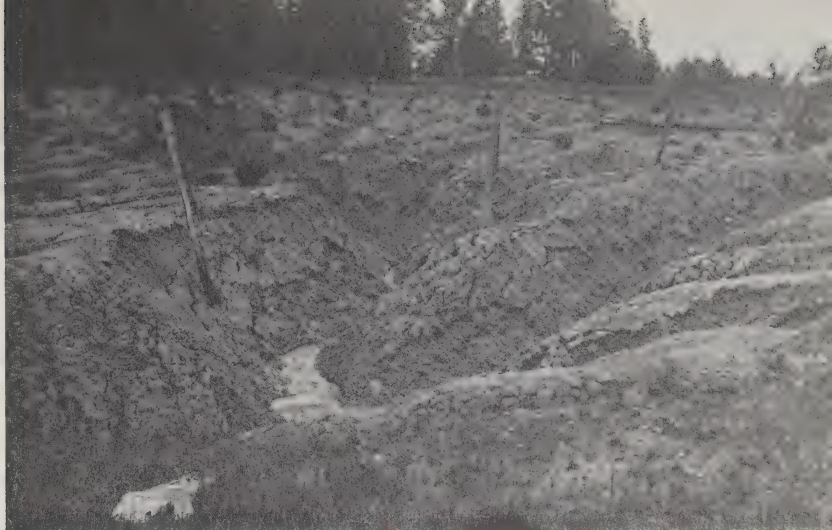
Advanced rill erosion in Concession V, Essa Township. Lack of top soil and vegetative cover are prominent.

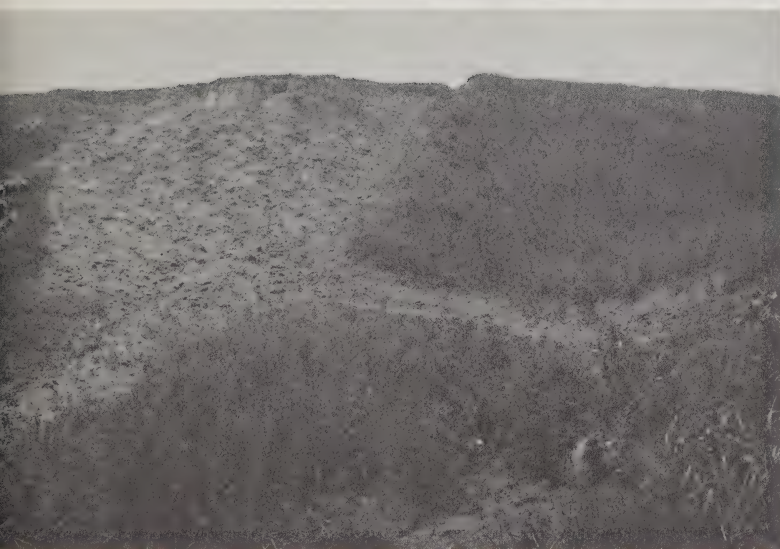
Bank erosion in Concession IV Essa Township caused by cattle. Control is necessary to prevent further deterioration and the formation of gullies.

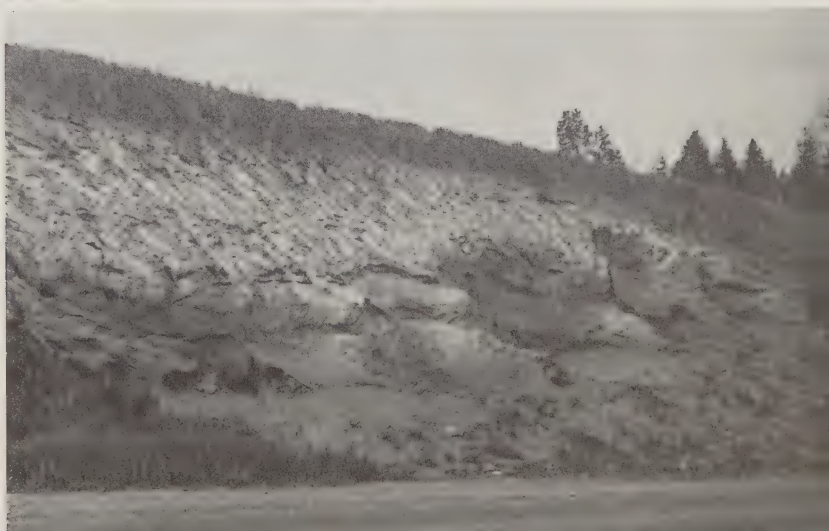
Poorly designed road cut resulted in this accelerated erosion of the slope.

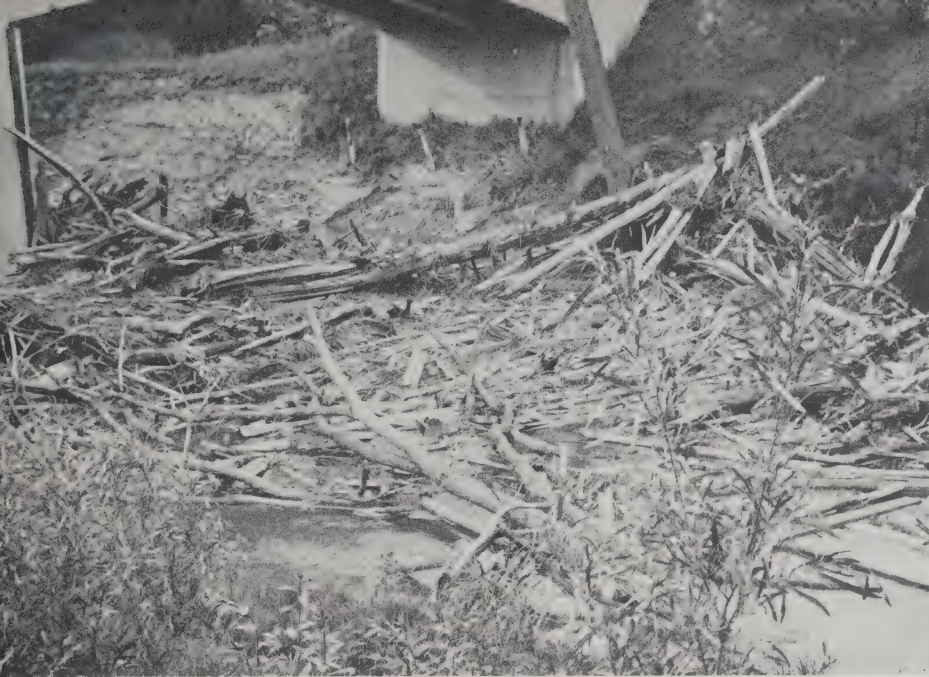
Severe streambank erosion at Nottawasaga River Bridge has resulted from this log jam.

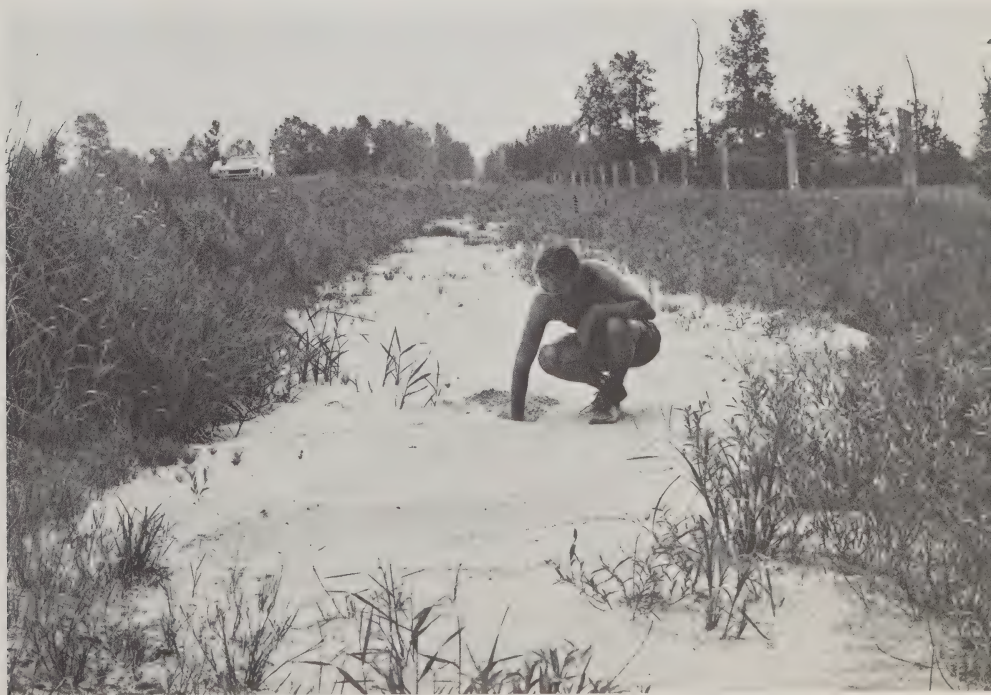
Spring flooding frequently leaves sediment deposits in roadside and field ditches. This example is in the Mad River Floodplain downstream of Angus.

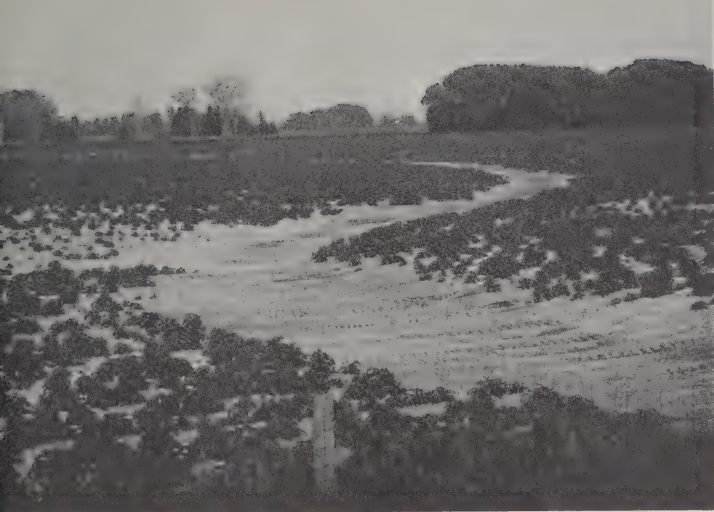
Construction of a grass waterway combined with contour tilling practices would reduce soil erosion in this potato field (Concession I, Essa Township).

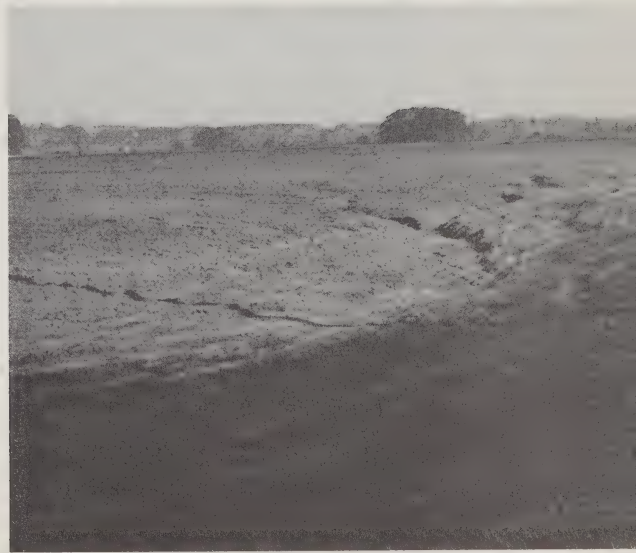
A well-maintained grass waterway would reduce field erosion and lower maintenance costs of ditches and culverts. Location — Concession IV, Essa Township.

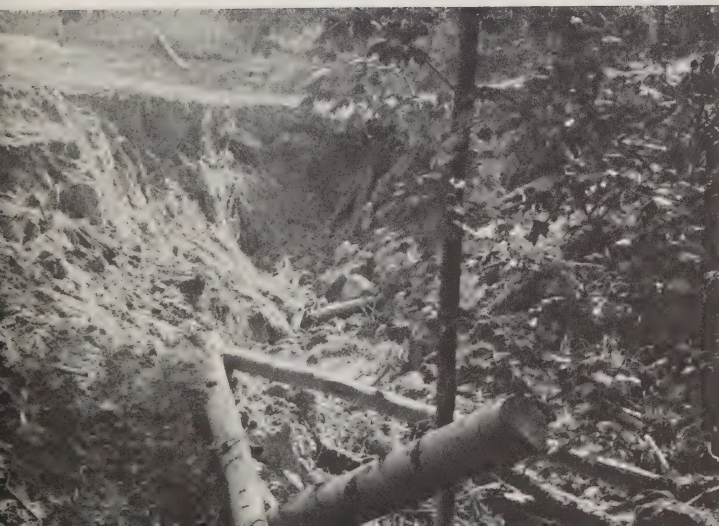
Poor construction practices in ski-slope building resulted in this accelerated soil erosion at a skiing area in Mono Township.

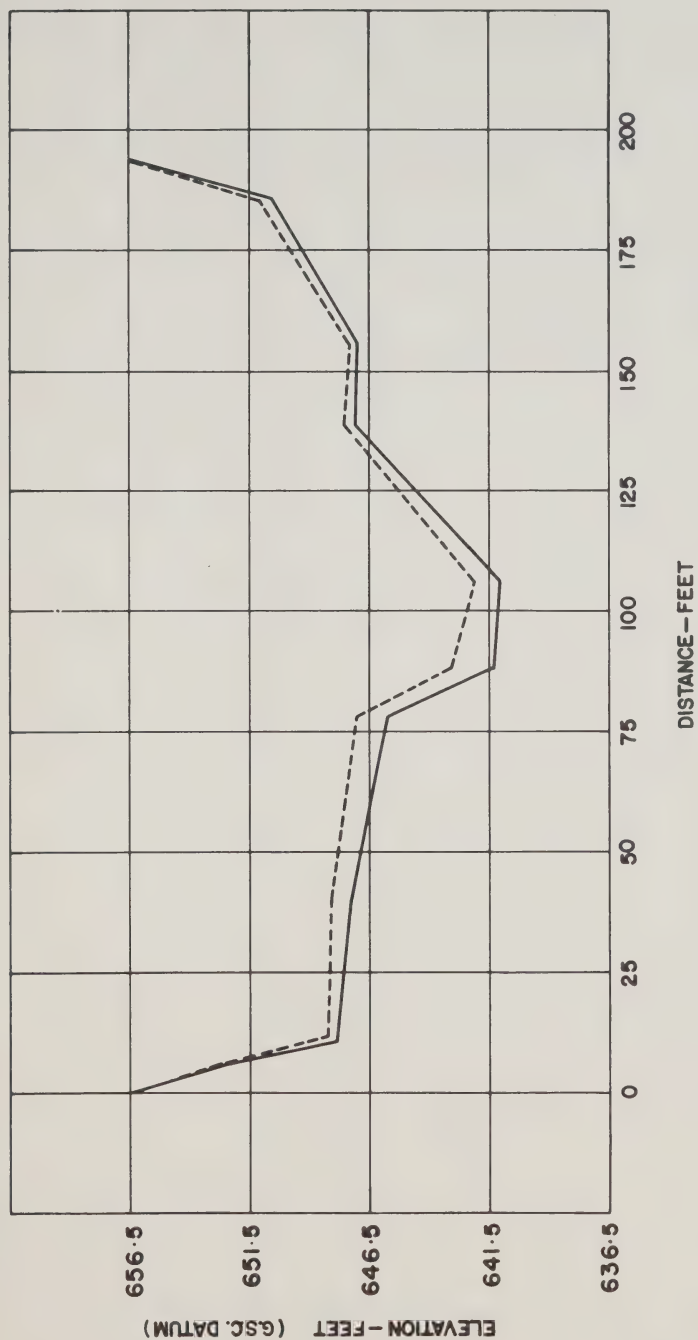
FIG. 3-4

TYPICAL CROSS-SECTION OF UTOPIA RESERVOIR SHOWING SEDIMENT ACCUMULATION

(AS MEASURED IN 1972)

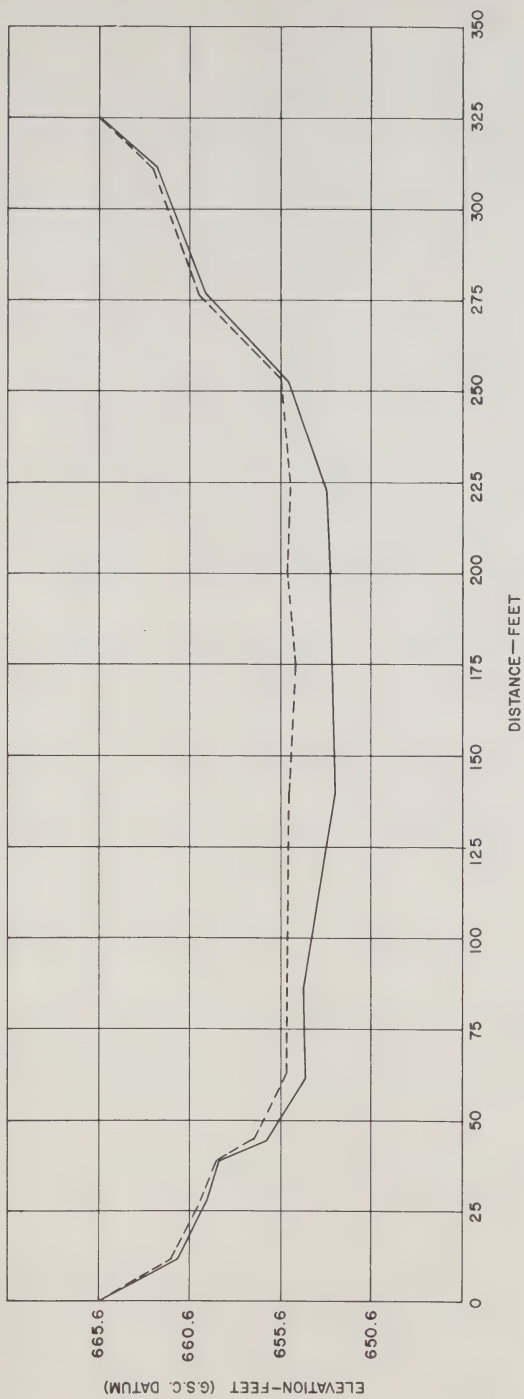
FIG. 3-5

**TYPICAL CROSS-SECTION OF NEW LOWELL RESERVOIR
SHOWING SEDIMENT ACCUMULATION**
(AS MEASURED IN 1972)

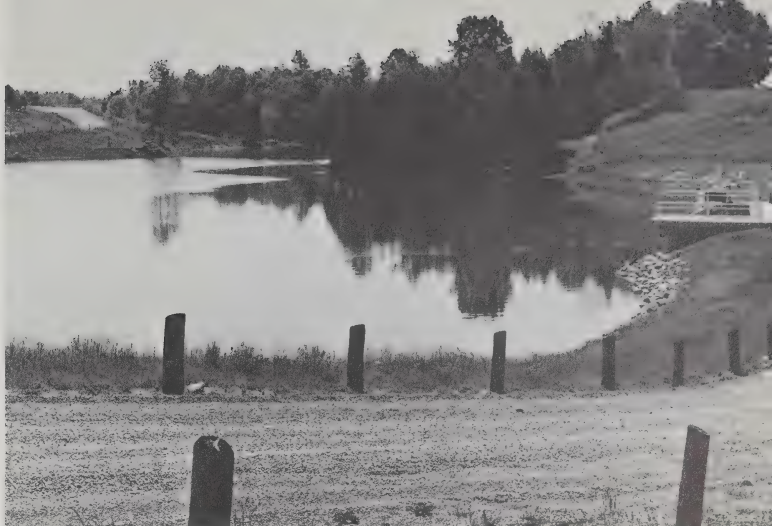
The Utopia Dam and Reservoir from the North embankment. Multi-purpose reservoirs enhance water management by providing recreational facilities and water for low flow augmentation.

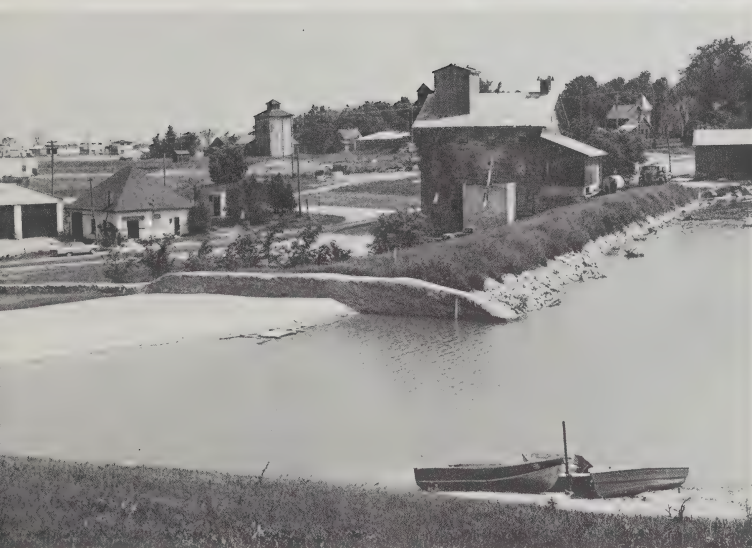
Dam and reservoir at Tottenham. Rehabilitation of older structures provides added benefits.

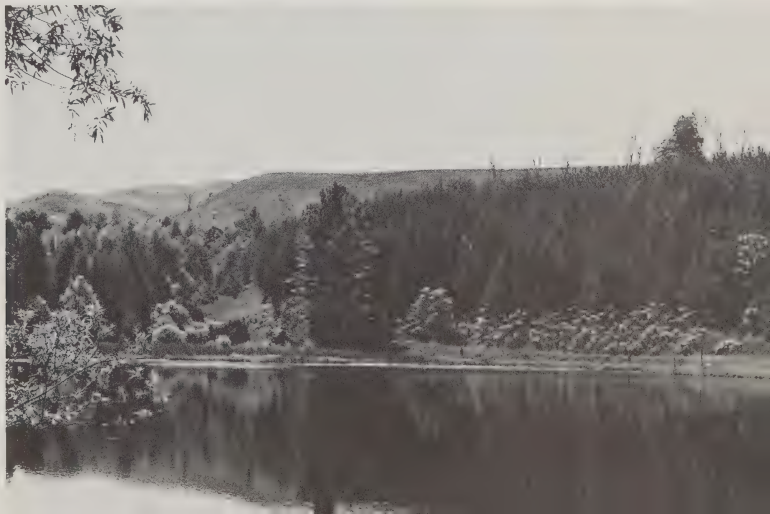
This pond in Concession I, Mulmur Township, is typical of the many ponds throughout the headwater regions of the principal rivers in the Nottawasaga Watershed.

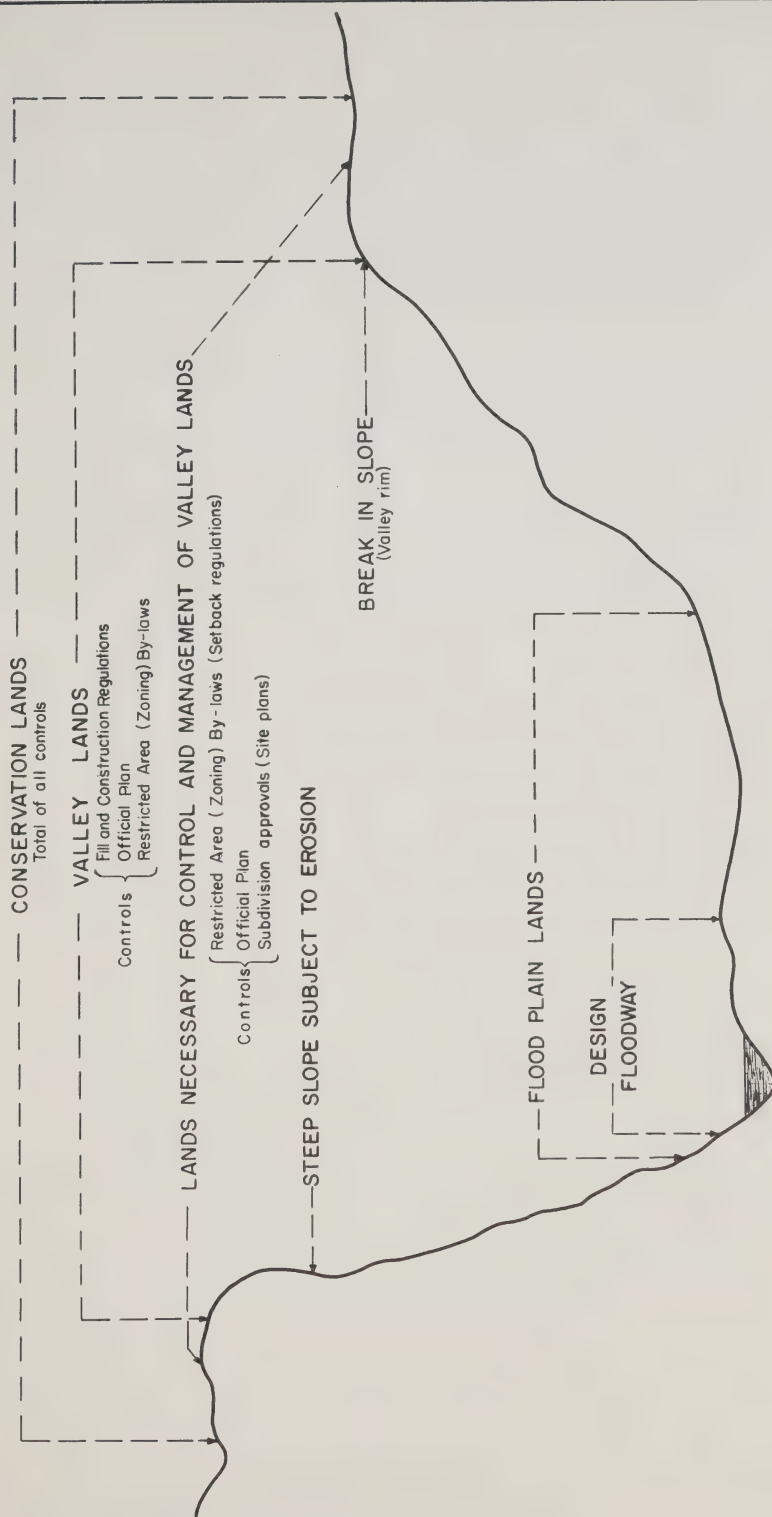
FIG. 4-1

TYPICAL CROSS SECTION OF A RIVER VALLEY
AND POSSIBLE LAND-USE CONTROLS
